# Manhole Inspection Summary

Manhole # S49M\_\_009MH

Insp Date: **9/16/09 11:37 AM**

**Location** Address: **802 Lakewood St.**

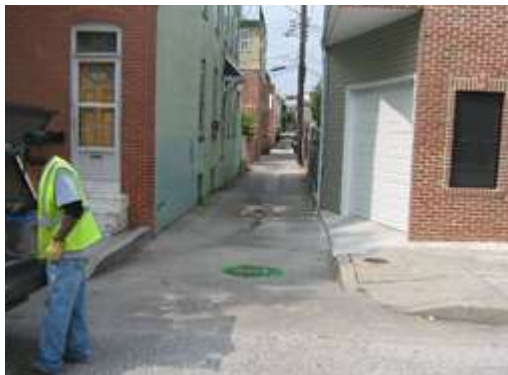
Location View

View facing west

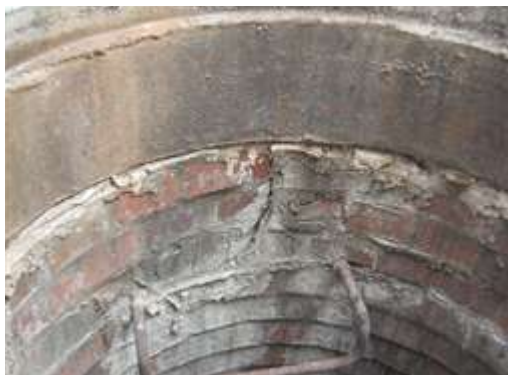
Defect 3

Condition: ☐ Sound ☒ **Cracked** ☐ Root Intrusion ☐ Loose Brick ☐ Deteriorated

cracked at chimney

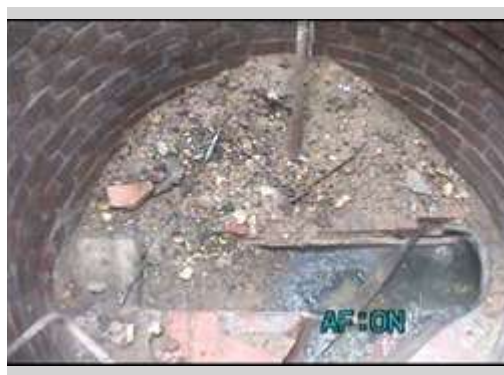
Defect 1

Condition: ☐ Sound ☐ Cracked ☐ Root Intrusion ☐ Deteriorated ☐ Leaks ☒ **Debris**

heavy debris in the channel and on the bench

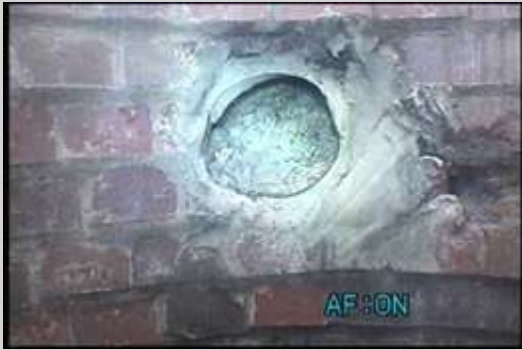
Pipe In @ 10 O'Clock

Comments **No 6 o clock pipe and the 10 o clock looks to be abandoned**

abandoned

Deposits: ☐ None ☐ Mud ☐ Sludge ☒ **Debris** ☐ Grease

Silt Depth: **4** (in.) Deposits Extent: **Heavy**

Pipe Seal Cond: **Broken**
